What Happened

After a devastating water loss caused by a ruptured sprinkler pipe in the attic, an outpatient surgical facility faced extensive damage throughout its sterile and non-sterile areas. The force of the water flow was so powerful that it even knocked off the lettering on the building's exterior. As a result, the facility had to temporarily halt operations until the issue could be resolved. Fortunately, the customer who had previously worked with CRC's Healthcare Team, reached out for assistance. The team was engaged as a Construction Manager Not-at-Risk to oversee the reconstruction project.

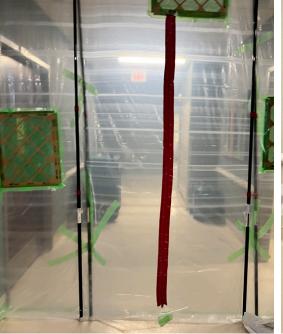
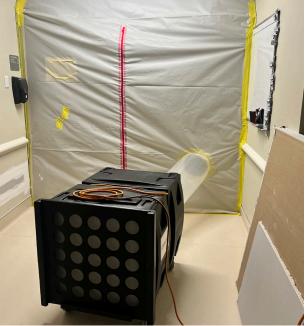
Comparison of containment practices:
Left – original contractor's inadequate ICRA considerations.
Right – CRC's compliant ICRA standards, featuring negative air pressure to minimize hazardous particle spread during construction.

CRC's Healthcare Team collaborated closely with the client to establish and implement Infection Control Risk Assessment (ICRA) requirements and clean the facility and contents affected by ineffective controls used by the initial general contractor. Additionally, CRC devised an aggressive schedule to restore the facility to normal operations within 15 days and complete the construction in 21 days.
